Case Study

Wigmore Street Grade A Commercial Office Space

"Too Good To Be True" Chemical Free Approach Cures Water Quality Issues in Just 3 Months.

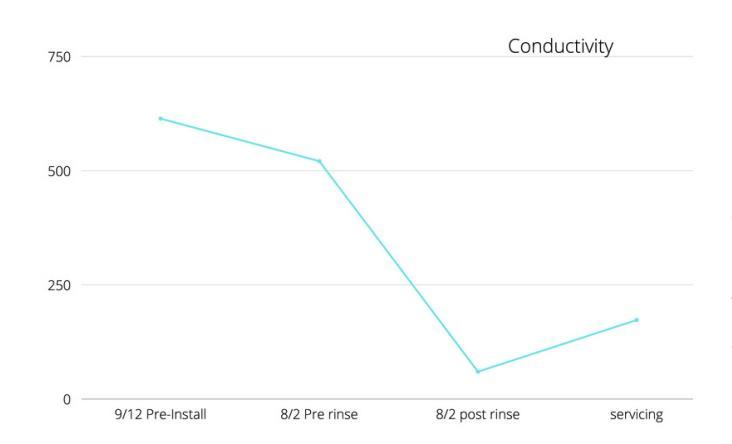
Good improvements were seen in the total and dissolved metal values in the system water compared to the quality pre install. The dissolved metal values which usually represent active corrosion are already in VDI recommended ranges. Initial Iron values were above 1 mg/l indicating corrosion debris present in the system and along with other metal values continues a downward trend whilst both hardness and chlorides are both at VDI2035 levels.

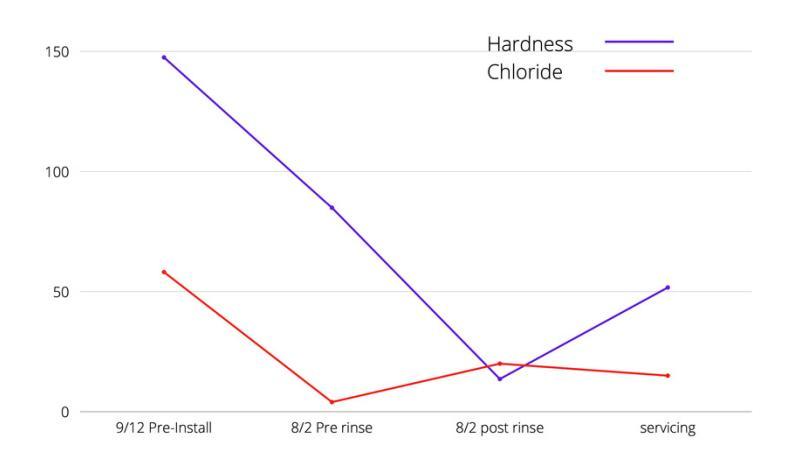
In just over a week from install the Resus Corrosion Meter showed the system water had moved the corrosion from 140µm/yr to below 20 µm/yr which is indicative of the Protector efficiently removing DO from the system. pH was maintained between 8.7 and 9.2 for the POC period which is in line with VDI2035 water quality requirements. Conductivity of the system decreased from 614 uS/cm at the time of installation to 60 uS/cm immediately post rinse.
